# Bare Board Material Performance after Pb-Free Reflow

## Abstract:

The High Density Packaging Users Group (HDPUG) consortia completed an extensive study of 29 different bare board material and stackup combinations and their associated performance after 6X Pb-free reflow at 260°C. Data presented will focus on the air-air thermal cycling, IST testing and material survivability after Pb-free assembly reflow portions of this testing. Test board design aspects, manufacturing processes, Weibull analysis, and failure analysis data will be presented. The impact of plated through hole pitch on laminate integrity and how material properties relate to the results will be discussed.

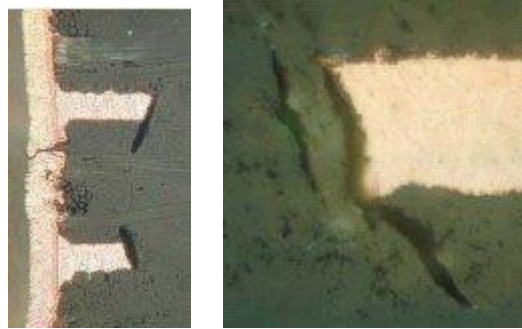
**Figure 14**

Inspections of cross-sections of coupons that were subjected to reflow simulation revealed numerous instances of via-to-via pitch-dependent internal laminate structural defects. No signs of this damage were noted during Celestica's careful inspection of the outer surfaces of these coupons after reflow simulation. No signs of these internal defects were noted during inspection of cross-sections of IST coupons that were not subjected to reflow simulation.

Eyebrow cracks (see Figure 14) were found at the outer periphery of some internal lands. These tend to occur at what appears to be the copper-to-resin interface along most of the vertical portion of the end of the internal land. These often extend for a short distance in a generally diagonal pathway above and/or below the unused land and/or may extend for a short distance along the horizontal interface between the land and the laminate.

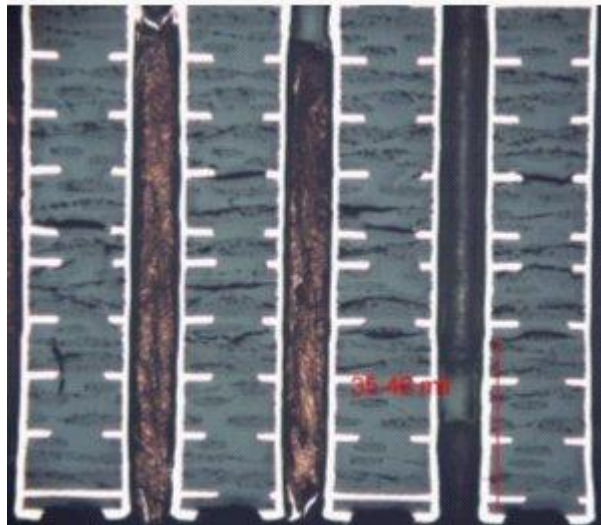
**Figure 15**

Longitudinal cracks (see Figure 15) extend horizontally (often completely or almost completely) between adjacent vias. These are seen in one or more layers within a given cross-section. These occur within layers that are within the middle third of the stack-up, with a predominance of these being near the center of the stack-up. The majority of cracks include at least some vertical component, sometimes following the sinusoidal pattern of the glass bundles. Besides being at the glass-to-resin interface, these may exist within the resin and/or at the copper-to-resin interface and/or at the core-to-prepreg interface.

Although the eyebrow cracks observed in this study were fairly short, this type of defect remains of generic concern relative to the potential for CAF formation between vias and nearby power or ground planes. Longitudinal cracks are of even greater concern, given their often longer lengths.

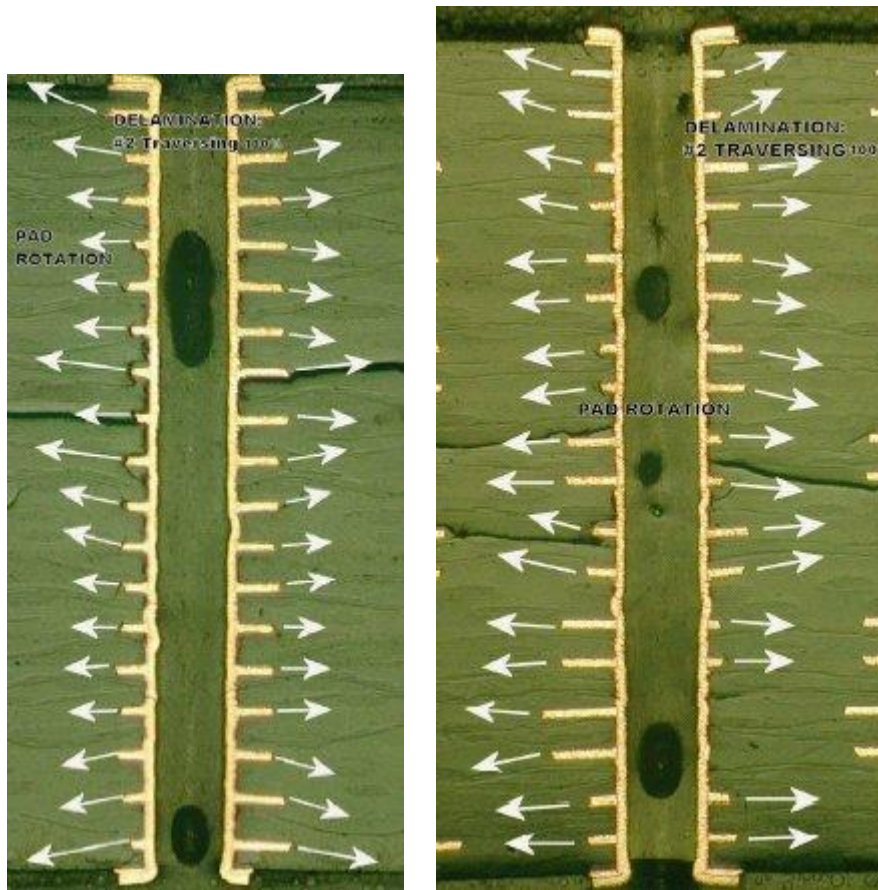
Noted elsewhere in this report (and reported for other testing<sup>8,9,10</sup>) are examples of reflow simulation appearing to extend the cycles-to-failure of ATC and IST coupons relative to coupons that didn't undergo this preconditioning. Associated with reflow simulation-induced laminate cracking within the test coupon, Bill Birch of PWB Interconnect Solutions has attributed this to stress redistribution. Figure 16 shows examples of vias that experienced more cycles before failure compared with the case for sister coupons that did not experience reflow simulation. The directions of bending of the internal lands suggests that the vias essentially became subdivided into two zones, thereby extending their apparent lifetimes beyond what they would be in the absence of what is surmised (see above) to be otherwise undesirable laminate cracks.
