FALSE TIN WHISKERS: MASQUERADING TIN COPPER INTERMETALLICS

David Hillman
Rockwell Collins Inc.
Cedar Rapids, IA, USA
ddhillma@rockwellcollins.com

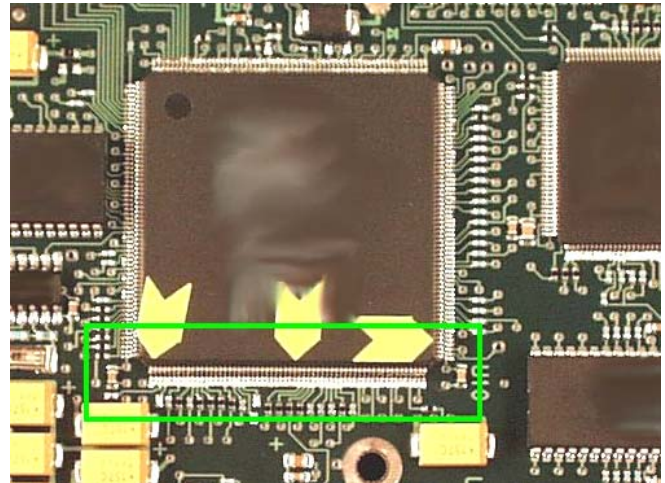
In March of 2007, a Rockwell Collins assembly auditor notified a process industrial engineer of whisker-like anomalies on a Quad Flat Pack (QFP) component. Figure 1 illustrates the printed wiring assembly and QFP component. Optical inspection of the QFP component revealed a large quantity of anomalies that appeared to be tin whiskers. Figure 2 illustrates the anomalies observed during the inspection.

Figure 1. Printed Wiring Assembly and Anomaly Location on QFP

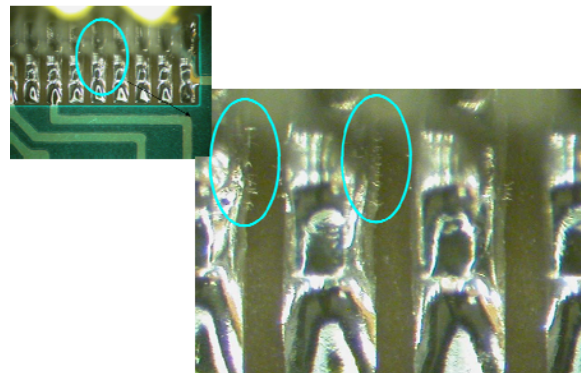
Figure 2. Anomalies Observed During Optical Inspection of QFP (Top); Magnified Optical View of Anomalies (Bottom)

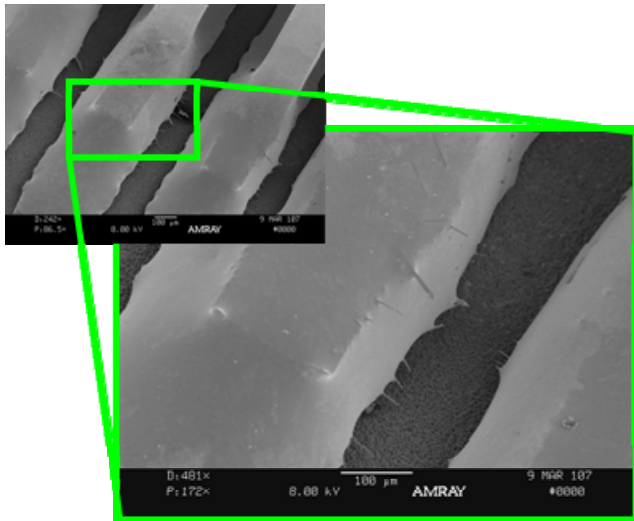
Photodocumentation of the printed wiring assembly was completed and the QFP component carefully removed for Scanning Electron Microscopy (SEM) analysis. The QFP solder joints showed good solder joint wetting and acceptable solder joint geometries. The identified anomalies were predominately located at the specific features associated with the solder joint (i.e. the component lead and the printed wiring board pad). Figure 3 shows the anomalies protruding from the upper edge of the QFP lead and in the region of the printed wiring board pad.

Figure 3. Anomaly Observations during SEM Analysis

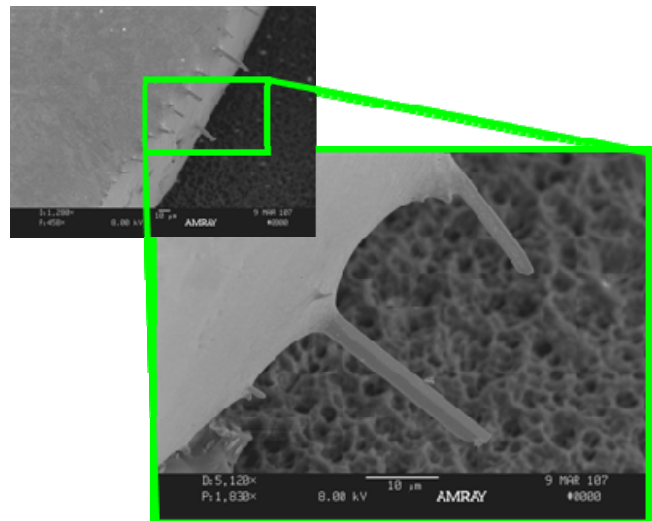
Figure 4 illustrates additional anomalies observed during the SEM analysis. The whisker-like protrusion in Figure 5 shows a hexagonal cross-section, ordered spacing and surface wetting at the anomaly base near the tin/lead solder. Several of the anomalies were observed to be hollow and filled with tin/lead solder (Figure 6).

Figure 4. SEM Images of Whisker-like Anomalies (Top); Magnified View of Anomaly (Bottom)

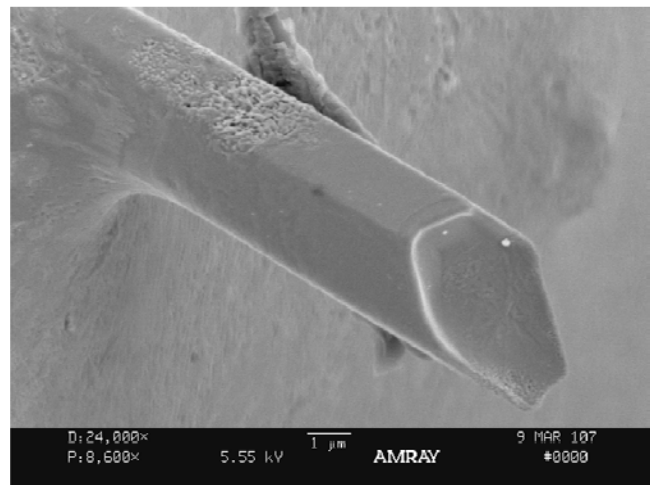
Figure 5. SEM Image of Whisker-like Anomaly

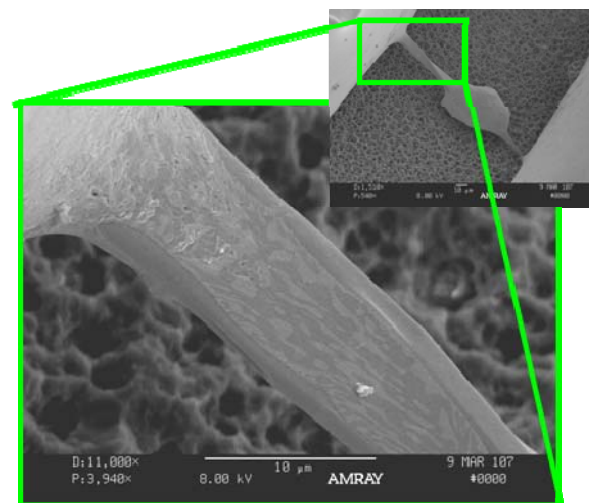
Figure 6. SEM Image of Anomaly Filled with Tin/Lead Solder

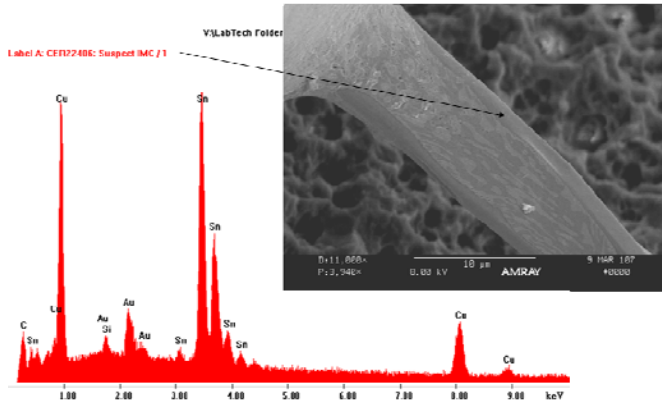
determine their elemental composition. The outer shell of the anomalies was determined to be a tin/copper alloy with a rough element ratio of six parts copper to five parts tin (Figure 7). The material contained within the anomaly was determined to be tin/lead solder from the soldering process thus demonstrating that the anomaly was a hollow structure (Figure 8). The gold indications shown in the SEM EDS measurements is an artifact of the gold sputter coating applied to the QFP as part of SEM analysis preparation.

Figure 7. SEM EDS of Whisker-like Anomaly Outer Shell

The SEM analysis results revealed the true identity of the whisker-like anomalies observed on the printed wiring assembly. The SEM EDS results show the copper/tin element ratio of the anomalies to be approximately six parts copper to five parts tin which would correspond to the Cu_6Sn_5 tin/copper intermetallic (IMC) phase [8]. The Cu_6Sn_5 tin/copper IMC phase forms in a needle morphology as the copper content of the solder begins to exceed approximately 0.3% [9, 10]. The Cu_6Sn_5 intermetallic needles often form and grow preferentially from component lead and/or printed wiring pad edges. The SEM analysis shows the same behavior for the whisker-like anomalies on the QFP component. The formation and observation of Cu_6Sn_5 intermetallic needles solder joint microstructure is a typical occurrence. Figure 14 illustrates Cu_6Sn_5 IMC needles produced in a typical wave solder process solder joint. Additionally, the Cu_6Sn_5 intermetallic needles have a hollow, hexagonal geometry in contrast to tin whiskers which are solid striated structures that often have bends or kinks. Figure 15 illustrates a typical tin whisker compared to the Cu_6Sn_5 intermetallic needles observed in the investigation. Tin whiskers form and grow in random, not in an ordered orientation to each other. The typical length of the observed Cu_6Sn_5 IMC needles was 0.001 inches. The Cu_6Sn_5 IMC needles are a fixed length and do not increase over time as tin whiskers have been observed. The Cu_6Sn_5 IMC needles pose a minimal electrical shorting risk that would be identified during product quality testing prior to product shipment.

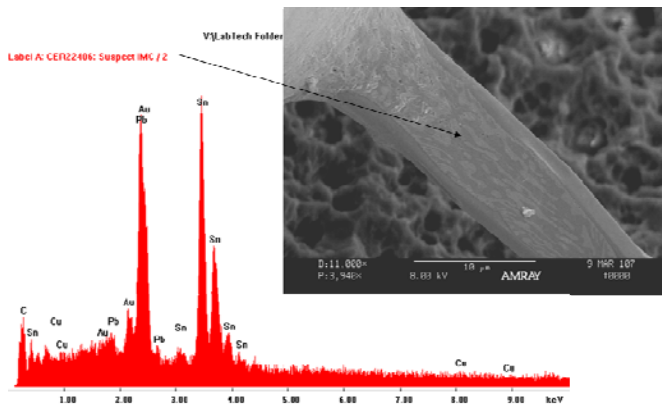
Figure 8. SEM EDS of Whisker-like Anomaly Fill Material

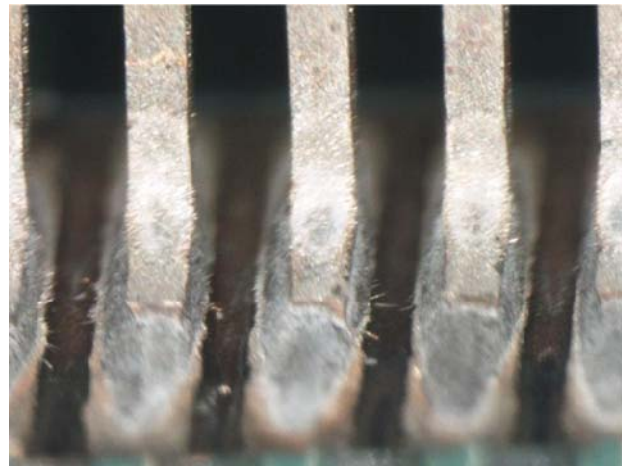
The QFP SEM sample was subjected to a 10% hydrofluoric acid/ 90% ethanol etching solution to remove the tin/lead solder but leave the whisker-like anomalies intact. The sample was immersed in the etchant solution for two minute intervals, carefully rinsed in deionized water and optically examined for the extent of the tin/lead solder removal. After eight minutes, a sufficient amount of solder had been removed to expose the anomalies and the etching process was halted. Optical examination and SEM analysis was conducted after etching. Figure 9 shows an optical view of the QFP sample after completing the etching process.

Figure 9. QFP Sample after Completing Etching Process

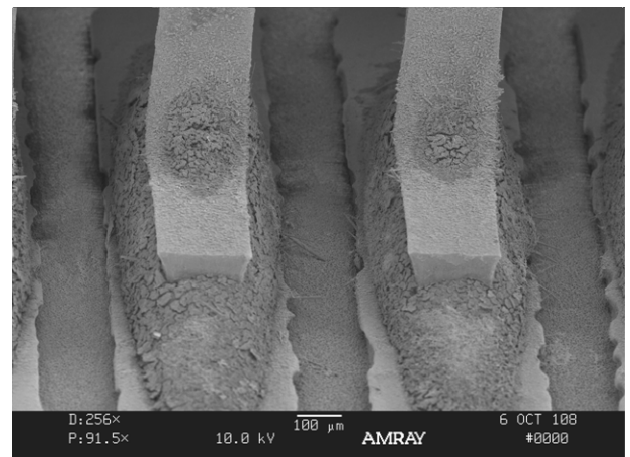
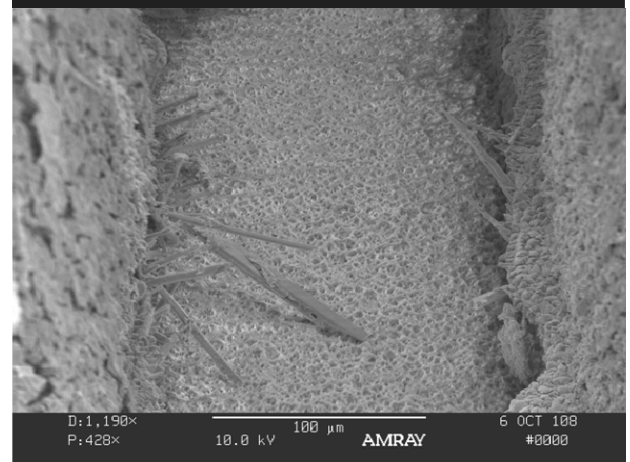
SEM analysis of the etched sample revealed that the anomalies were originating from both the QFP lead and the printed wiring board pad. The predominate anomaly shape was a hexagonal geometry with several of the structures observed to be hollow. Figure 10 through Figure 13 illustrate anomalies observed on the etched QFP during the SEM analysis.

Figure 10. SEM Images of the Anomalies on the Etched QFP Sample

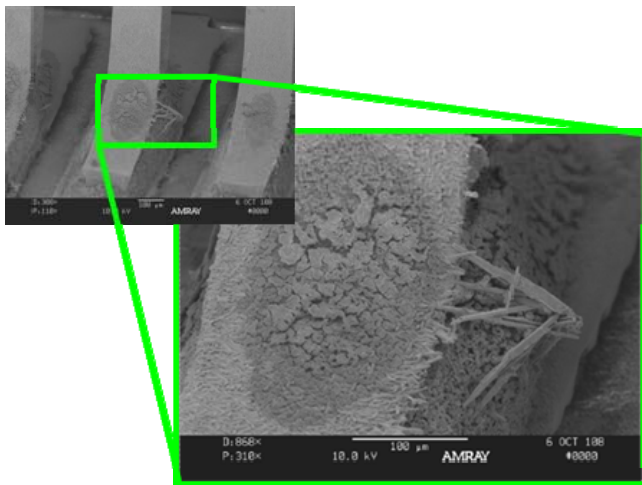
Figure 11. SEM Images of the Anomalies on the Etched QFP Sample

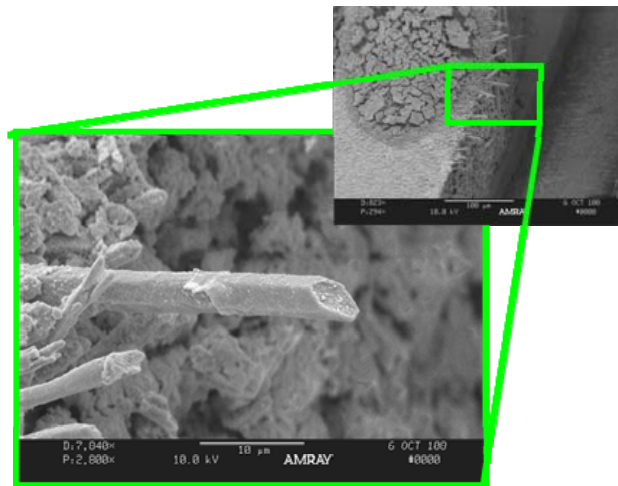
Figure 12. SEM Images of the Anomalies on the Etched QFP Sample

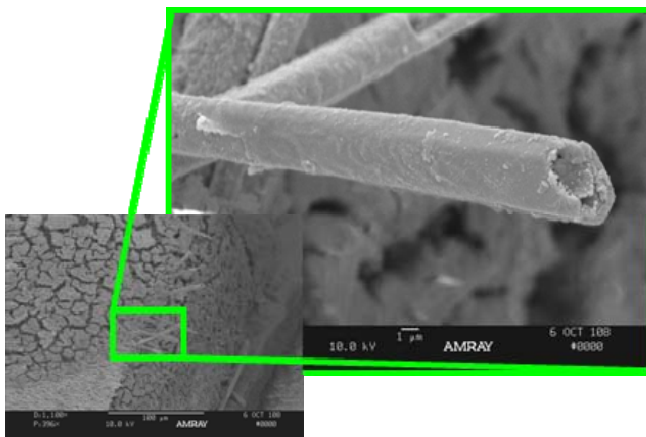
Figure 13. SEM Images of the Anomalies on the Etched QFP Sample
