Pockets of Contamination That Are Causing Field Failures and How to Avoid Them

Eric Camden
Foresite, Inc
Kokomo, IN

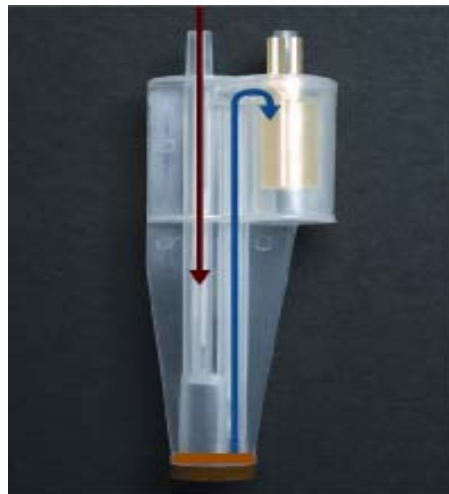
Figure 1 Diagram of localized steam extraction test and collection cell

The designed system uses a deionized steam extraction system to collect a 2.2 ml sample from a 0.1 in² area of circuitry. The system produces a microburst of steam that is allowed to soak for 20 seconds, and is then aspirated into a collection cell. This steam is applied 5 times to achieve effective residue removal from the area of analysis. After 9 collection cycles, an electrical test is performed across a sacrificial y-pattern electrode to check for electrical leakage. 10v of electricity is applied, and the system makes a determination after 60 seconds as to whether or not the sample is 'clean' or 'dirty'. The current threshold for considering a sample clean is 500 μ A, and is based on 13 years of data collection through ionic analysis in failure analysis applications. The electrical test continues to run for two minutes after the cleanliness determination is made, and current readings are recorded in the testing program. The extracted sample can then be used for ion chromatography analysis to determine the exact type and quantity of the localized contamination.

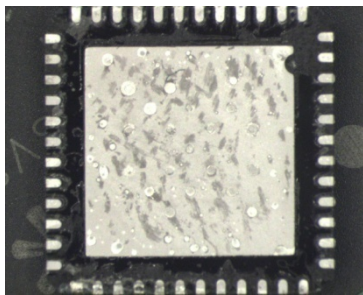
Figure 2 Bottom of PQFN with Flux

one flux activator group, and gave readings of high weak organic acids (WOA). These residues were coming from marginal cleanliness levels of the bare board and components combined with the flux used in wave solder.

All of these elements combined and trapped under the PQFN package create a very high risk for conductive pathways to form. It was found that they used a nominal range profile for the reflow oven used with the no-clean paste. We tried modifying to a higher reflow profile, but there was still gooeey, non-complexed flux under the package. The reason for this phenomenon is that as the weight of the PQFN package collapses over the molten solder paste during reflow, flux from the outside is sinking over and becoming trapped underneath the package where it cannot be complexed and released. The PQFN, which sits atop solder paste at a 6 mil stencil thickness, is able to drop down to 3-4 mils, thus trapping the flux and blocking the solvent path of volatilization. The parts were sheared off of the assembly to perform the site specific extraction and further testing with ion chromatography, results are in Table 1, photo of underside of component with flux in figures 1&2.

We were asked to develop a corrective action plan to prevent future field failures, and recover the contaminated assemblies through rescue cleaning. This customer implemented several corrective actions suggested by Foresite in order to prevent the flux entrapment. The first recommended action was a design change suggested which was to remove some of the pads from underneath the PQFN components. Fewer pads mean lowered opportunities for contamination. The final design change

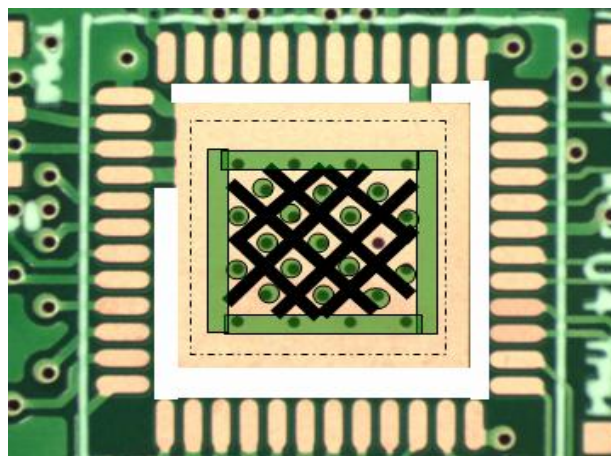
Figure 4- Depiction of PQFN recommended changes and details

1. Remove inside area soldermask (except on ground contact pads or attach the ground to the thermal vias on the other side and eliminate traces to ground pad)
2. Reduce Center pad by 15% on all sides
3. Plug all via's with mask and place
4. Solder mask in the mask defined area with diamonds (black)

suggested was the widening of the gap between the power and the ground. This wider spacing decreases the risk of bridging. In addition to these design changes, also suggested was closer monitoring of solder paste deposition, and the use of less solder paste and to monitor the cleanliness levels of incoming bare boards as well as the components. To analyze whether or not these suggested changes were effective in eliminating the problem of goeey contamination under the PQFN parts, we analyzed additional samples manufactured with the original process, and compared them to assemblies manufactured with the suggested design changes. As seen in the analysis from table 2, the original process produced assemblies with high amounts of weak organic acid flux residues, and still exhibited a thick, goeey flux residue underneath the PQFN components. The assemblies built with the suggested design changes, including modified spacing and pad placement, showed acceptable low levels of weak organic acid residues. The flux residue was able to volatilize under these conditions, and all ionic residue levels for these assemblies fell within limits for reliable field performance. Table 2 shows ion chromatography results on follow up samples with suggested changes; figure 3 is a depiction of changes made to component design and details.

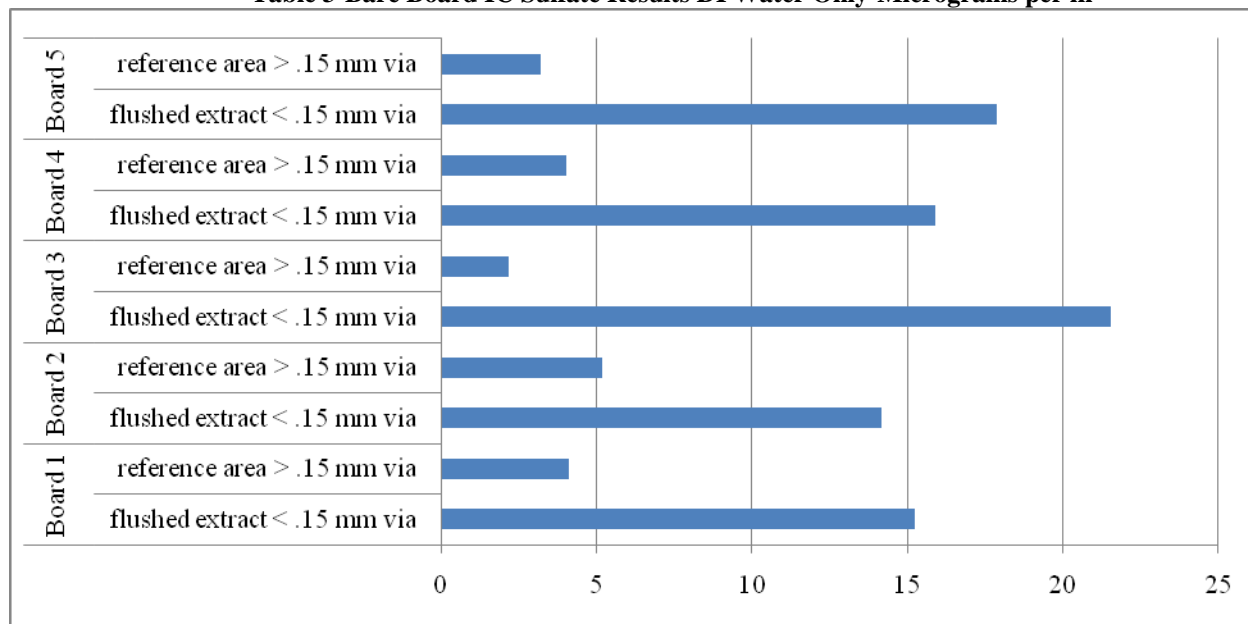
Table 3-Bare Board IC Sulfate Results DI Water Only-Micrograms per in²

A companion issue to flux residue beneath the PQFN package is a concern with contaminated vias, especially when directly under components. We have found a few bare board fabricators that historically have had no issues with bare board cleanliness that were being asked to put tighter cleanliness acceptance levels in place because of the sensitive nature of the surface mount PQFN problems previously discussed. When the process window tightens, all of the materials involved must be held to cleaner standards than ever before. For years, vendor X produced boards with typical levels of <3 +/- 2 from time-to-time on sulfate without issue, but when one of the assembly houses began building with several of the PQFN packages, a series of field failures were found directly related to cleanliness underneath these low standoff components. A study of via cleanliness was performed, and areas with vias >.15 mm were found to be much cleaner than the vias that were smaller than that. Simple surface tension was the main culprit. The normal DI water alone was not able to penetrate the smaller vias, and remove the etchants used in processing. The level of sulfate residues in addition to other process residues, and a normal amount of humidity found in service, was enough to cause the failures (see table 3). A 5% solution of saponifier/DI water was put in place, and this was enough of a decrease in surface tension to access the etchant residues entrapped in the smaller vias, and adequately rinse them out (see table 4). Levels dropped to very comparable sulfate residue amounts across the surface of the bare board. We have not found any further field failures to date with this product related to the cleanliness in vias issue.
