FALSE TIN WHISKERS: MASQUERADING TIN COPPER INTERMETALLICS

David Hillman
Rockwell Collins Inc.
Cedar Rapids, IA, USA
ddhillma@rockwellcollins.com

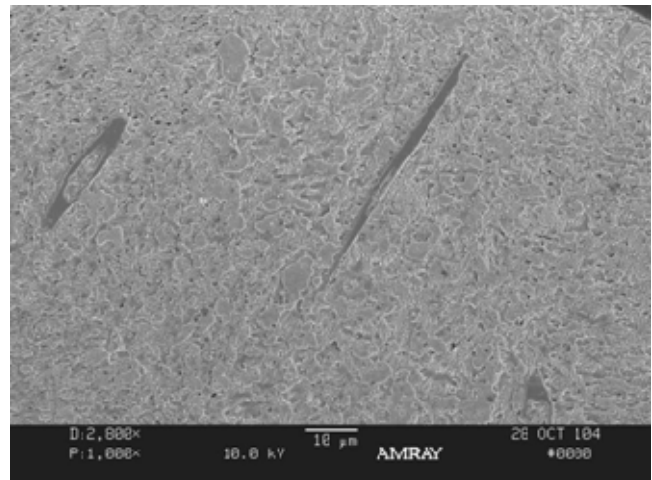
The SEM analysis results revealed the true identity of the whisker-like anomalies observed on the printed wiring assembly. The SEM EDS results show the copper/tin element ratio of the anomalies to be approximately six parts copper to five parts tin which would correspond to the Cu_6Sn_5 tin/copper intermetallic (IMC) phase [8]. The Cu_6Sn_5 tin/copper IMC phase forms in a needle morphology as the copper content of the solder begins to exceed approximately 0.3% [9, 10]. The Cu_6Sn_5 intermetallic needles often form and grow preferentially from component lead and/or printed wiring pad edges. The SEM analysis shows the same behavior for the whisker-like anomalies on the QFP component. The formation and observation of Cu_6Sn_5 intermetallic needles solder joint microstructure is a typical occurrence. Figure 14 illustrates Cu_6Sn_5 IMC needles produced in a typical wave solder process solder joint. Additionally, the Cu_6Sn_5 intermetallic needles have a hollow, hexagonal geometry in contrast to tin whiskers which are solid striated structures that often have bends or kinks. Figure 15 illustrates a typical tin whisker compared to the Cu_6Sn_5 intermetallic needles observed in the investigation. Tin whiskers form and grow in random, not in an ordered orientation to each other. The typical length of the observed Cu_6Sn_5 IMC needles was 0.001 inches. The Cu_6Sn_5 IMC needles are a fixed length and do not increase over time as tin whiskers have been observed. The Cu_6Sn_5 IMC needles pose a minimal electrical shorting risk that would be identified during product quality testing prior to product shipment.

Figure 14. Typical Cu_6Sn_5 Intermetallic Needles Located in the Solder Joint Microstructure

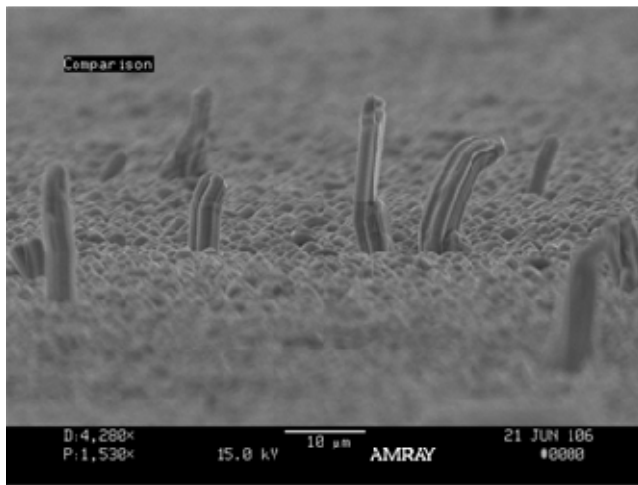
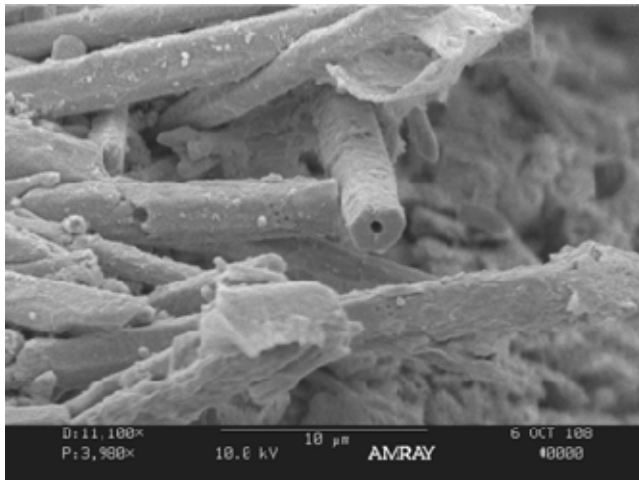
Figure 15. Comparison of Tin Whiskers (top) and Cu_6Sn_5 Tin/Copper IMC Needles (bottom)

The whisker-like anomalies protruding from the solder joints were not tin whiskers but a Cu_6Sn_5 tin/copper intermetallic needle shaped structures caused by the QFP component's tin/lead solder coating containing excessive copper levels. Only two other QFP solder joints exhibited

A review of the printed wiring assembly history revealed that QFP component had not been placed during the automated assembly process, due to a QFP availability issue. The QFP was manually soldered by an operator as a post automation operation. Further investigation of the operator's QFP soldering procedure did not reveal any unusual or incorrect soldering technique or procedure. Analysis of the QFP component surface finish revealed an excessive copper content in the tin/lead coating due to a prior pretinning operation. The manual soldering operation temperatures, combined with the excessive copper content, resulted in the formation of the Cu_6Sn_5 tin/copper intermetallic needles. A solder wick and re-solder process was conducted on QFPs that exhibited the Cu_6Sn_5 tin/copper intermetallic needles and no recurrence of the Cu_6Sn_5 tin/copper intermetallic needles was observed after completion of the process.
