Relationship Between Via Size and Cleanliness

Eric Camden
Foresite
Kokomo, Indiana

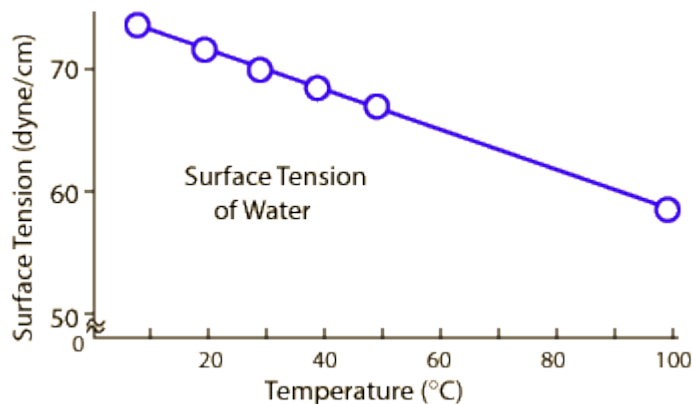
Figure 3-Surface Tension of Heated Rinse Water

When considering via cleanliness, Foresite's hypothesis lies in the thought that the surface tension of heated deionized water does lower the surface tension (figure 3) it is still too high to properly flush out and clean all of the etchant residues in the microvia sites. Lower surface tension makes it a better "wetting agent" to get into pores and fissures rather than bridging them with surface tension. Saponifier and wetting agents further lower the surface tension.

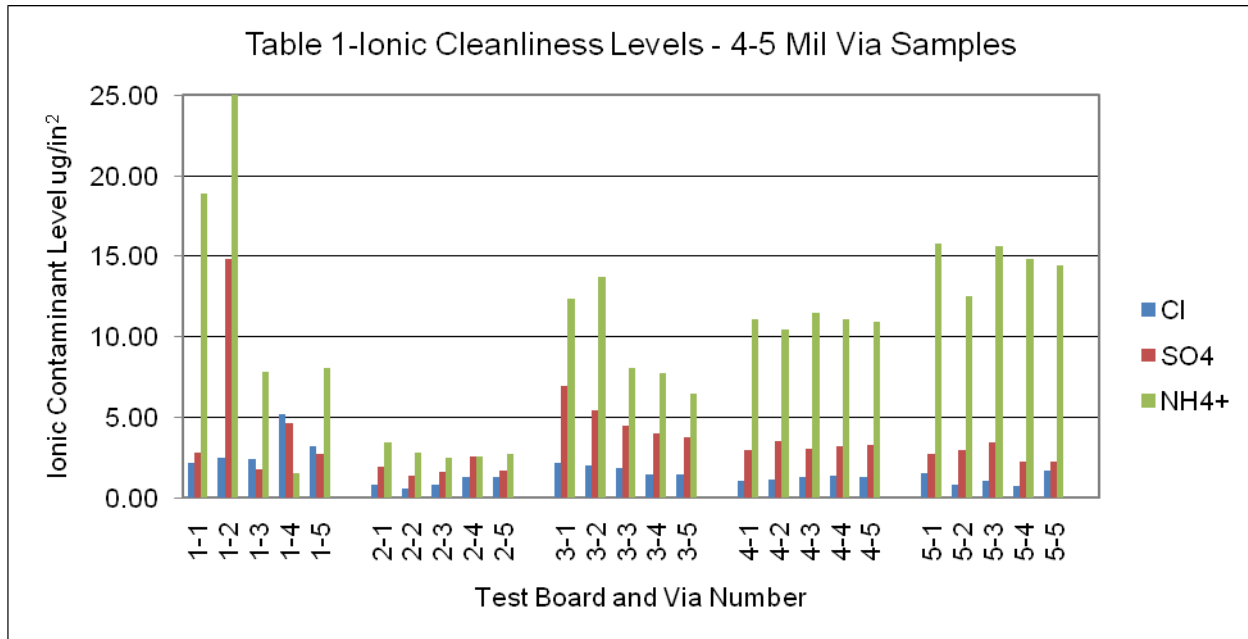
Table 2-Ionic Cleanliness Levels - 6 Mil Vias

In the charts below the ion chromatography results have been broken down into each via size and test board number (tables 1-6). A total of 25 extractions for each via size were performed across five test boards, with bare reference areas.
