# Thermal Cycle Testing of PWBs – Methodology

**Mike Freda, Sun Microsystems**  
**Paul Reid, PWB Interconnect Solutions**

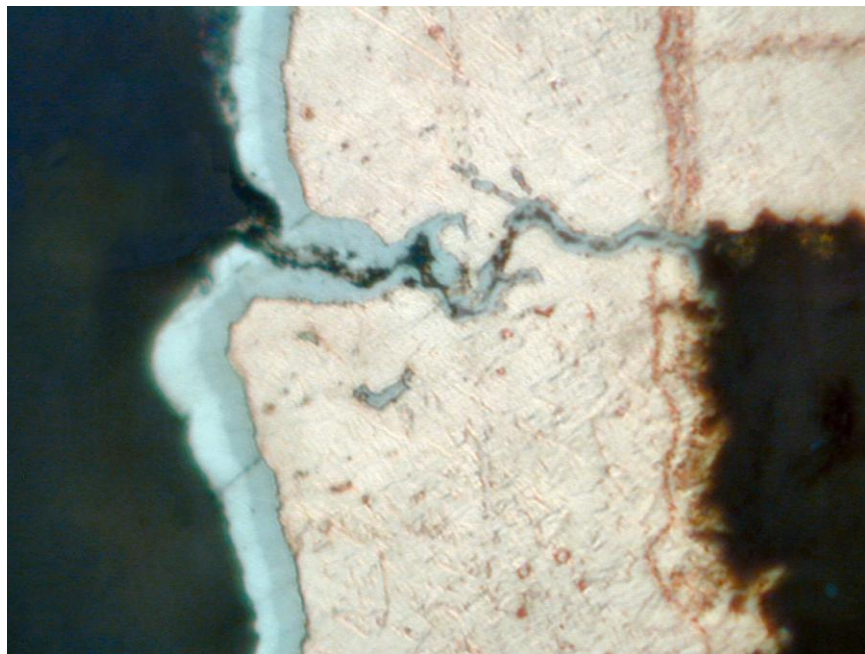
In high temperature testing and preconditioning where thermal excursions exceed the liquidous temperature of a solder finish, copper cracks made be bridged with solder. The effect is that cycles to failure are artificially extended due to solder filling the developing cracks. Instead of presenting a catastrophic failure the circuit appears self healing. If a coupon is subjected to high temperature thermal excursions like assembly and rework simulation and becomes damaged in the process the solder may reflow and fill the cracks in the PTH. If the coupon is then subjected to thermal excursions below liquidous, cracks frequently develop in the solder filling the original copper crack (figure 1).

Figure 1 - Copper Crack with Reflowed Solder Cracked

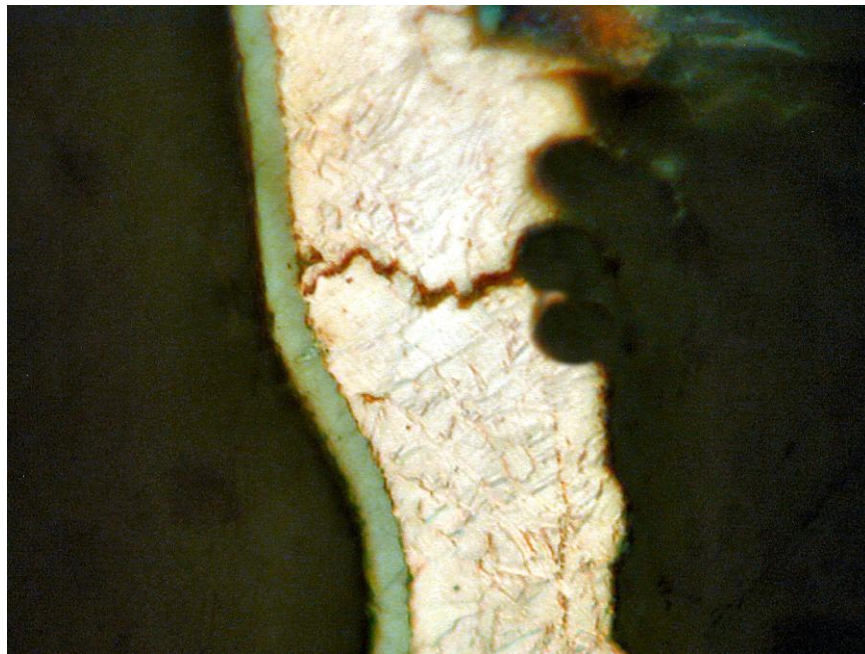
Nickel is robust in most applications extending cycles to failure. Cracks in the PTH start at a glass fiber and stop when the nickel layer is reached (figure 2). It should be mentioned, however, that occasionally nickel with nicks, bubbles, variable thickness, or nickel cracks may reduce thermal cycles to failure. Electroless nickel is known for even plating thickness throughout the PTH, while certain electrolytic nickel baths appears to be prone to variations in nickel thickness. With aspect ratios of 8:1 or greater, achieving a uniform and even nickel distribution throughout the barrel of the PTH can be a challenge. It appears that compromised nickel may initiate a crack which propagates toward the dielectric (figure 3). Weak nickel can reduce thermal cycles to failure. On well applied nickel the cycles to failure is significantly extended.

Figure 2 - Nickel Protection – Cracks Stops at Nickel Finish

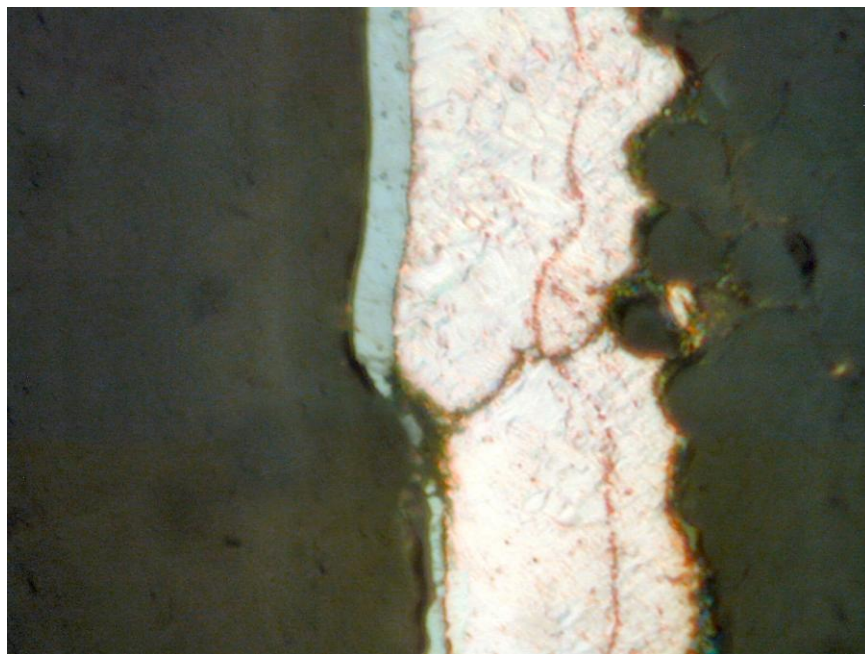
Figure 3 - Nickel Acceleration – Cracks Induced by Nickel Defect

If the goal of the investigation was to determine which of three materials is most robust then the presence of nickel would extend testing time and possibly confound the data. The subtle effects of roughly equivalent materials may well be masked by the presence of nickel in the surface finish.

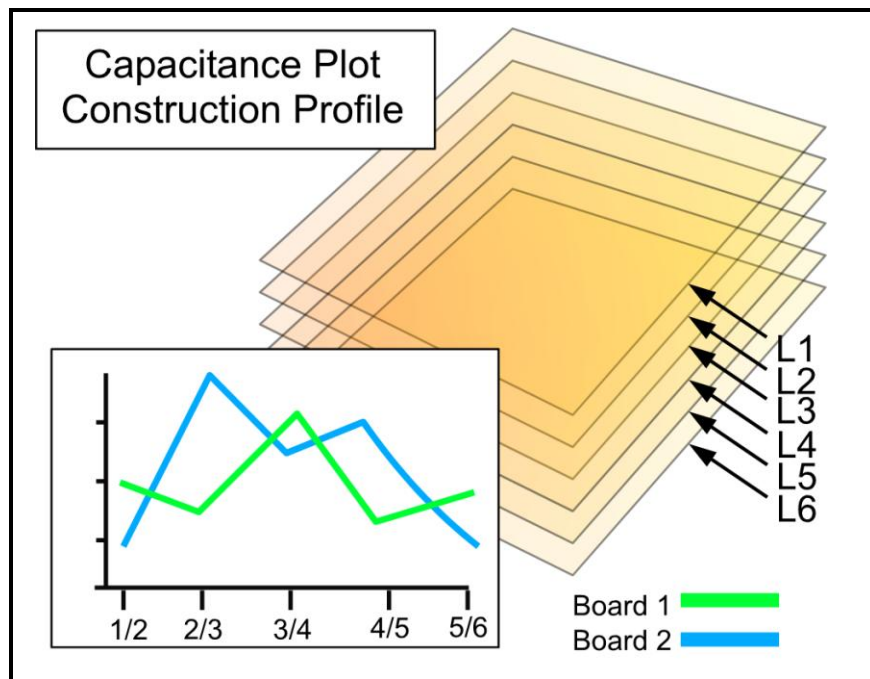
If capacitance circuits are available in the test vehicle then the capacitances between layers can be measured and two different coupons compared. Variations in construction are easily observed and variant coupons may be removed from the test group. Figure four demonstrates how the subtle differences in layup of two six layer coupons are demonstrated as changes in capacitance. Measuring the picofarads reading between the planes on each layer allows one to confirm or refute that two coupons have the same construction. Variation in the number of ply and glass styles each produce different construction profiles, based on capacitance measurements. If two dielectrics were being ranked for robustness, and variations in construction were found, then there would be concern that the test vehicles may not be equivalent and test data may be skewed.

Figure 4 - Construction Profile

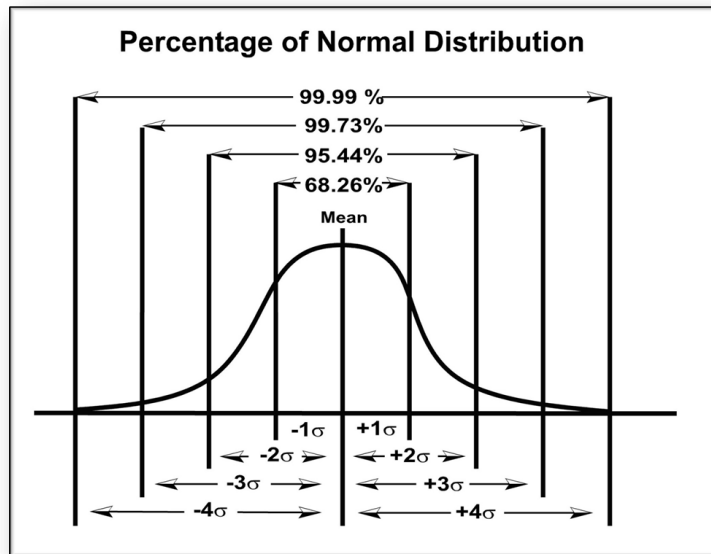
Common statistical analysis methods have the advantage of being universally understood, and they are easily calculated. Limits include they assume the distribution of the data is Gaussian or normal (figure 6) express as a bell curve and the method does not take end of test into account. The end of test result is, by convention, calculated as a failure.

Figure 6 - Standard Distribution – Bell Curve

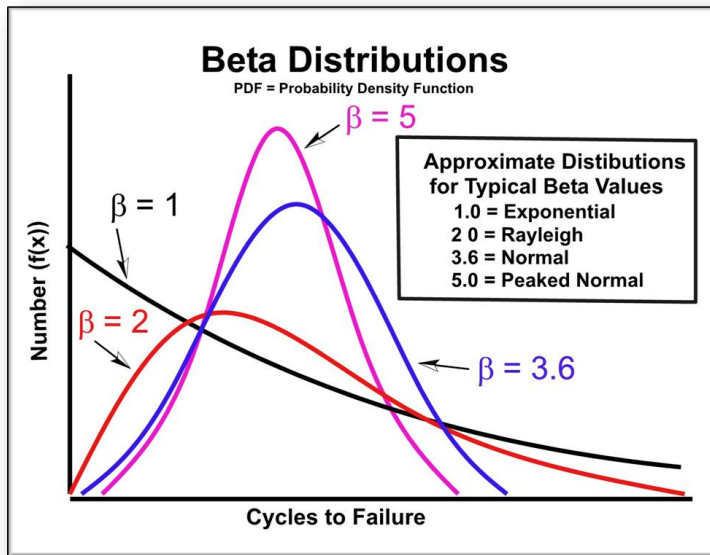
In reliability testing the distribution is rarely bell shaped and therefore the data may be skewed. Weibull analysis incorporates the shape number beta ( $\beta$ ). A beta of 1 is exponential, 2 emulate a Rayleigh distribution, 3.6 is normal and 5 is peaked normal (figure 7). When  $\beta$  is below 2.5 one should suspect that two or more failure modes with significantly different influence on reliability are present. If  $\beta$  is greater than 15, one may suspect that the test temperature may be too aggressive and a lower temperature may allow wider distribution, giving the test greater acuity to discern subtle variations.

Figure 7 - Weibull Probability Density Function Curves

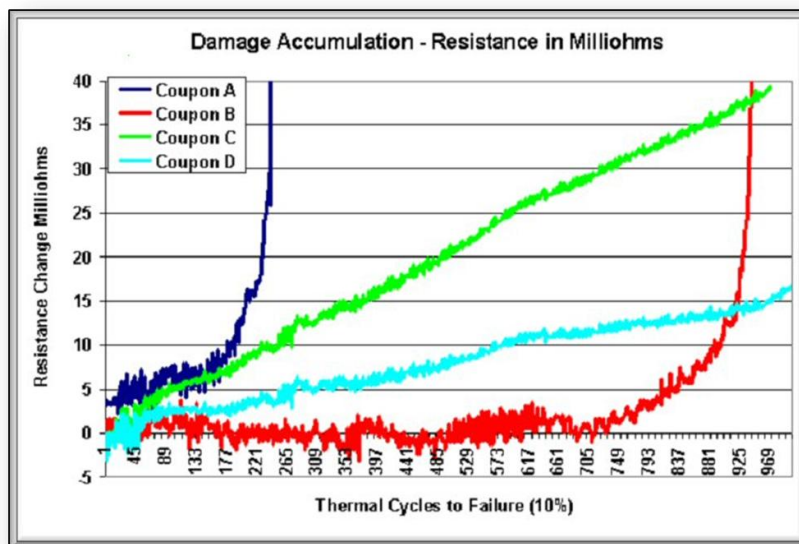
After testing is complete and if resistances at peak temperature have been recorded by the test method used, resistance graphs may be plotted. Resistance graphs (figure 8) are a plot of the change in resistance per thermal cycle. Resistance may be considered analogous to damage, typically due to cracks in the copper of interconnections. Resistance graphs give insight to the onset of damage and rate of damage accumulation. Resistance changes plotted against thermal cycles will show the onset and then acceleration of failure. Robust coupons fail slowly over time; usually thousands of cycles. Coupons that are weak will fail catastrophically in a few cycles. Coupons with material damage may present an accelerating damage accumulation, and then a flat or nearly flat plot reflecting the onset of the stress relieving effect of material damage. If the test is measuring resistance of more than one circuit at the same time in the coupon, then the effects of the two circuits may be compared to each other. Frequently one circuit will dominate damage accumulation, while other circuits are stress relieved or not influenced. Resistance graphs reflect the damage accumulation of the expressed and latent failure modes.

Figure 8 - Resistance Graph – Damage Accumulation

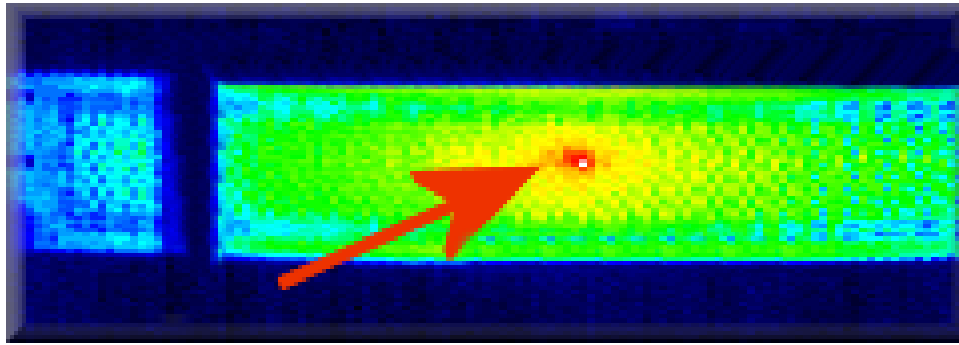
One of the most powerful tools in understanding the influences on reliability is failure site location in a failing circuit, by means of a low current and a thermal imaging camera. If testing is stopped promptly at a 10% increase in resistance, the failing circuit will still be conductive and a small current may be applied to the offended circuit while the coupon is being

viewed with a thermal imaging camera. The most damaged interconnection will have the highest resistance and heat up to a higher temperature than other, less damaged, interconnections, and is readily observed with thermal imaging (figure 9). This technique is usually applied to the first failed coupon in a group, the one that achieved the fewest cycles to failure. The single most damage interconnection out of hundreds may be located in this manner and a microsection processed of that specific interconnection. This allows a direct view of a failure that is developing, before it becomes catastrophically damaged to the point where meaningful failure analysis is impossible. With a microsection of the failed interconnection, one can view the dominate failure mode in the identified interconnect and latent failure modes in adjacent interconnections. Frequently the failure site is associated to conditions that violate the minimum standards, such as copper thickness, as defined in IPC-6012 and other applicable IPC documents.

Figure 9 - Failure Location with Thermal Imaging Camera – Failing Microvia

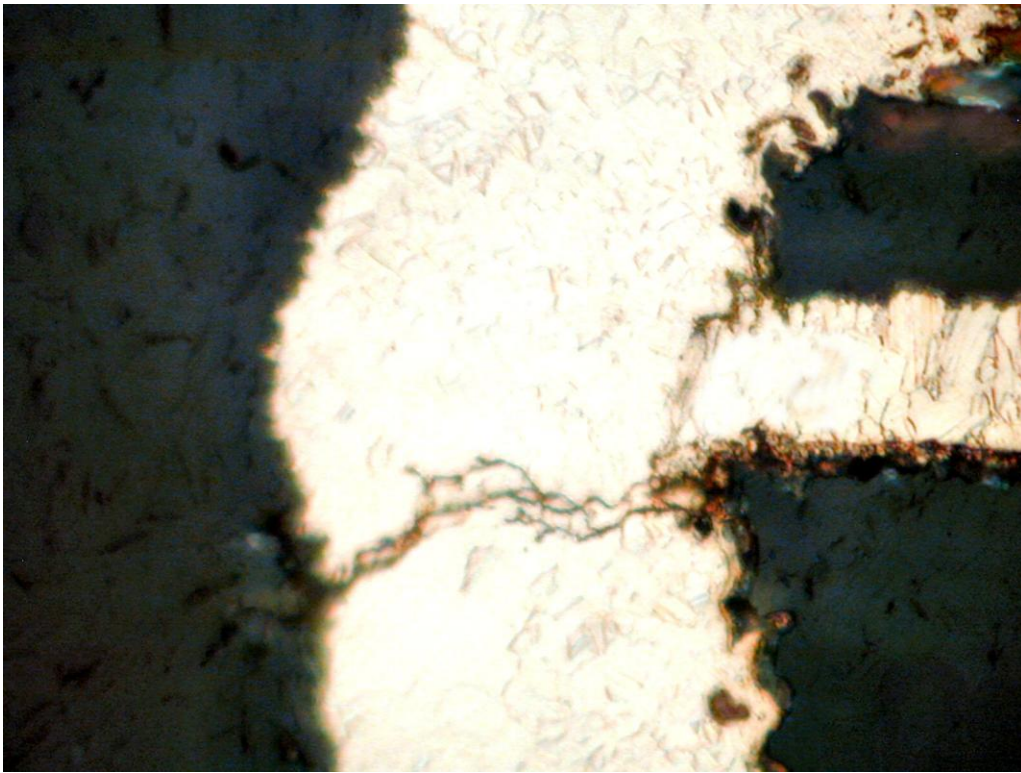
**Barrel Cracks due to Metal Fatigue:** Metal fatigue barrel cracks (figure 10) are a wear out mechanism. The crack usually develops over time and traverses the copper of the barrel of the PTH at a 20° to 50° angle from horizontal. A metal fatigue crack will typically propagate between copper crystals. These cracks are frequently closed at ambient. This type of failure mode is consistent with slowly accumulating resistance that does not accelerate during the life of the test. Robust coupons which survive thousands of thermal cycles will present this failure mode.

Figure 10 - Metal Fatigue Barrel Crack

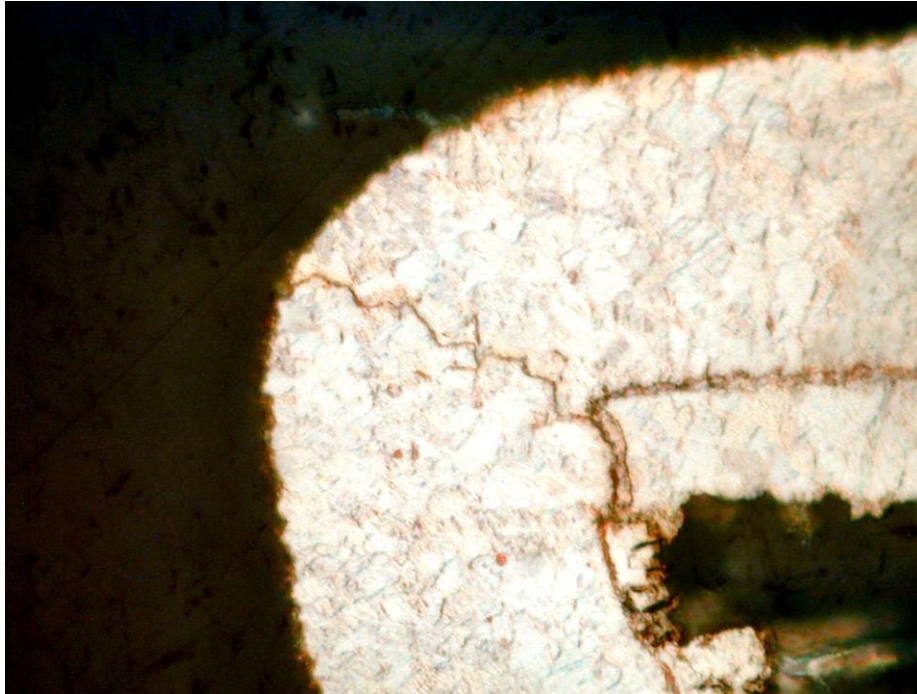
**Corner Crack - 45°:** Corner cracks (figure 12) are a result of pad rotation due to Z-axis expansion. The expansion of the dielectric material puts strain on the corner of the PTH producing a fracture line that proceeds up the face of the surface foil

and then across the plated copper at a 45° angle. Relatively small cracks can cause a 10% increase in resistance. Corner crack failures can be “wear-out” type failures where the copper at the corner is fatigued over time due to pad rotation as a result of repeated z-axis expansion associated with thermal cycling.

Figure 12 - Corner Crack at a 45° angle.

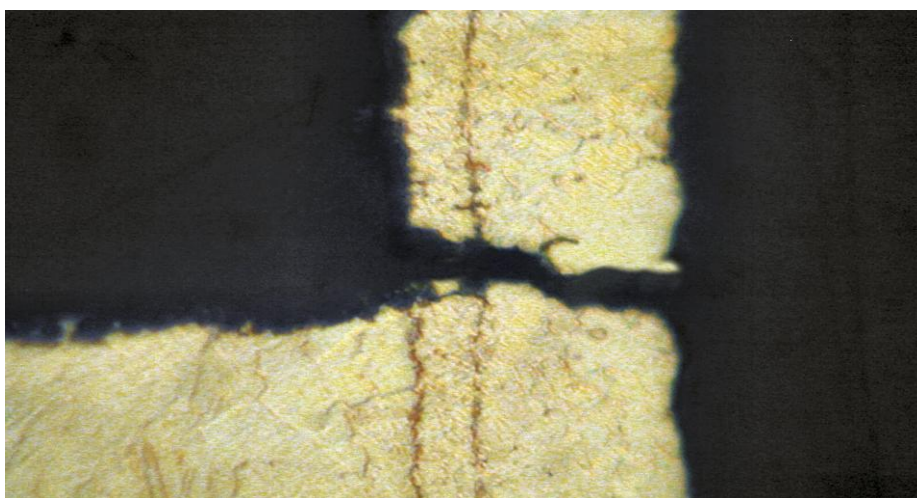
**Barrel Cracks:** Barrel cracks (figure 13) are expressed as a more severe type of PTH failure. In this failure mode the crack traverses the PTH at right angles frequently propagating through copper crystals. Because the crack is open at ambient plastic deformation of the dielectric is inferred. This suggests that there is material damage associated with a barrel crack type failure. This type of barrel crack usually transverses the copper at a 90-degree angle. This failure mode frequently presents a quickly accumulating resistance, after onset that accelerates to failure over a few thermal cycles.

Figure 13 - Barrel Crack - Open at Ambient

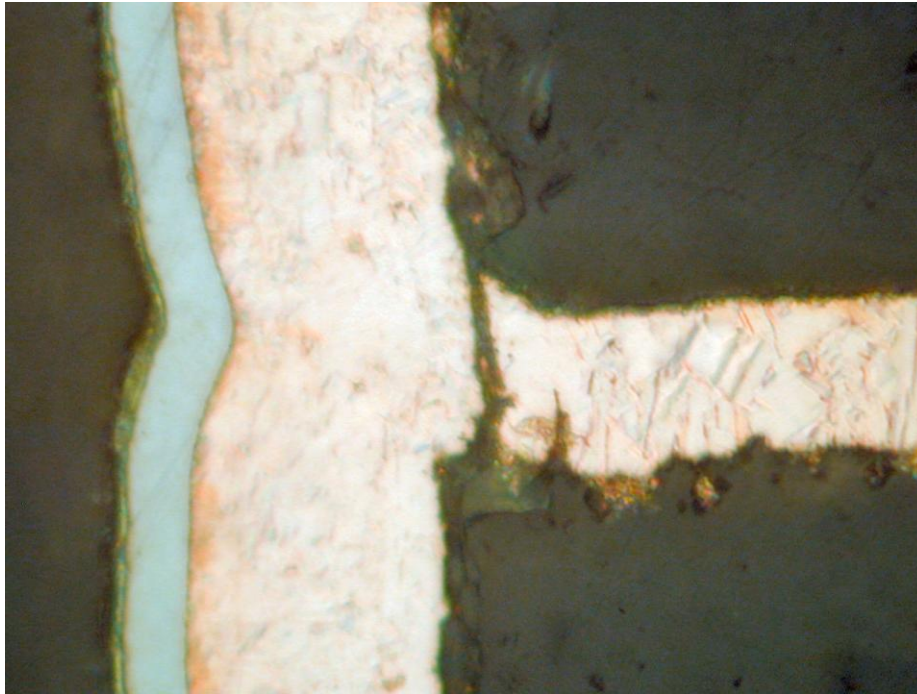
**Post Separation:** Post separation (figure 14) is a failure of the connection between the internal foil and the barrel of the plated through hole. This failure mode is exemplified by large separations between the copper in the PTH and the internal foil. The connection is frequently displaced out of plane from the original interconnection site. There is a large gap between the barrel and the foil and frequently the foil end is rounded. This type of failure is catastrophic with resistance graphs showing acceleration after onset

Figure 14 - Post Separation

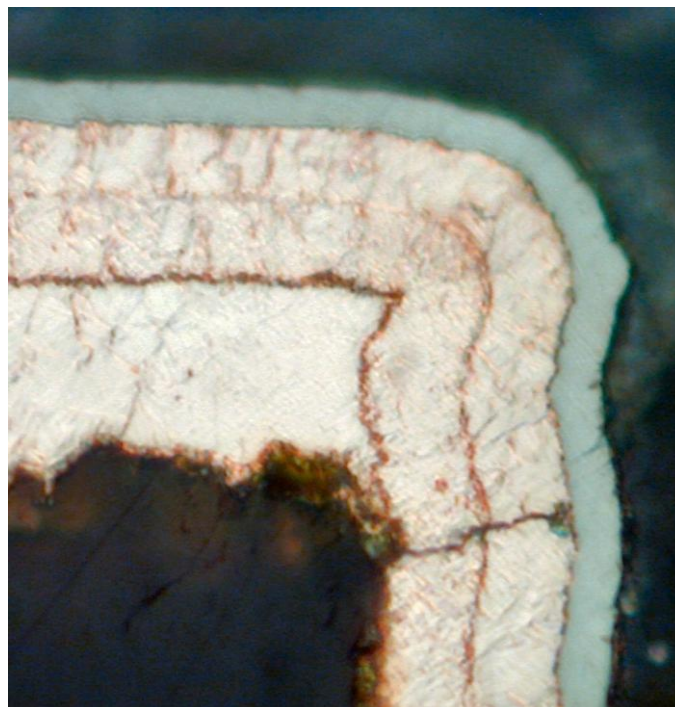
**Knee Crack- Horizontal:** It appears that there is a tendency, after exposure to lead/free preconditioning, for corner crack type failures to be expressed as a horizontal crack (figure 15) occurring just below the knee of the hole. This failure usually presents with accelerating damage, after onset, failing in a few thermal cycles.

Figure 15 - Corner Crack - Horizontal

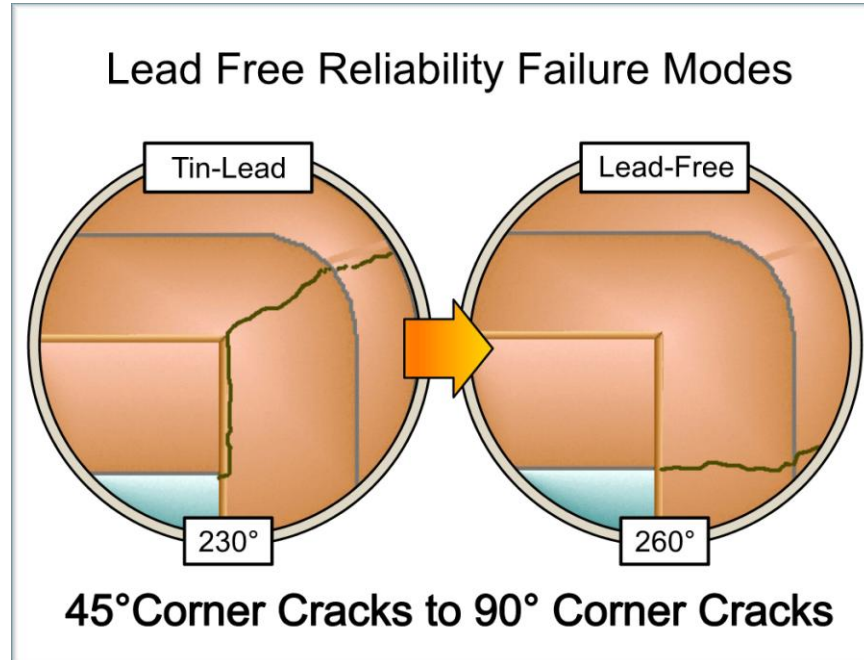
There are two trends that have been observed associated with lead-free assembly and rework. There is greater propensity for corner crack and these cracks are more frequently horizontal (figure 16).

Figure 16 – Lead-Free induced corner cracks

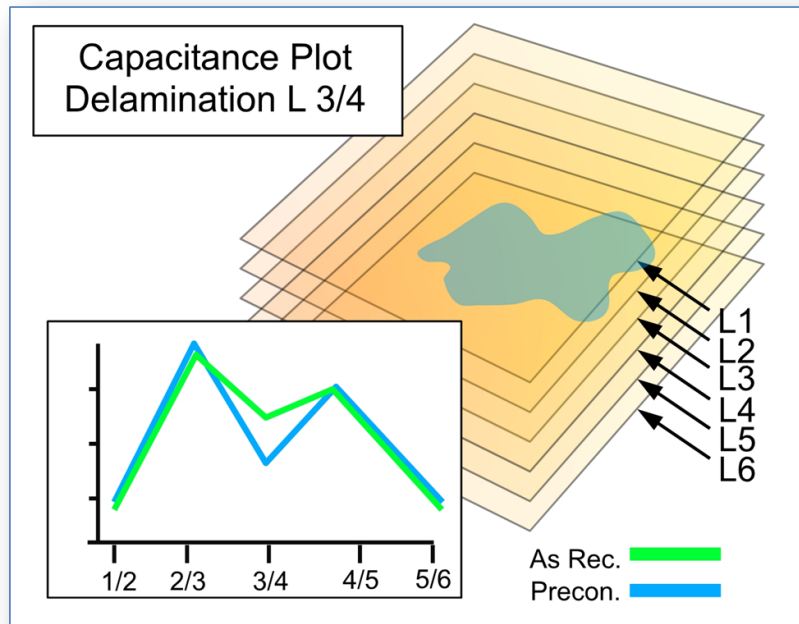
Assembly and rework at 260°C appears to be at the limit of most FR4 based dielectric system's temperature range, if PWB reliability is the standard. To that end, some test coupon designs (IST) are now incorporating capacitance planes on the layers that are ground planes in the PWB. These layers allow the measurement of capacitance, typically in picoFarads (fP) between planes. Subtle changes in the dielectric can be measured with this method. Material damages in to form of delamination, cohesive failure, crazing, material decomposition may be sensed. Other influences that can be sensed include changes in dielectric constant (i.e. curing) and moisture content. Measurements are taken and recorded in the "as received" coupon, after preconditioning and at end of test. Compared to baseline measurement a change in capacitance may reflect material damage (figure 17).

Figure 17 - Capacitance Layer with Delamination

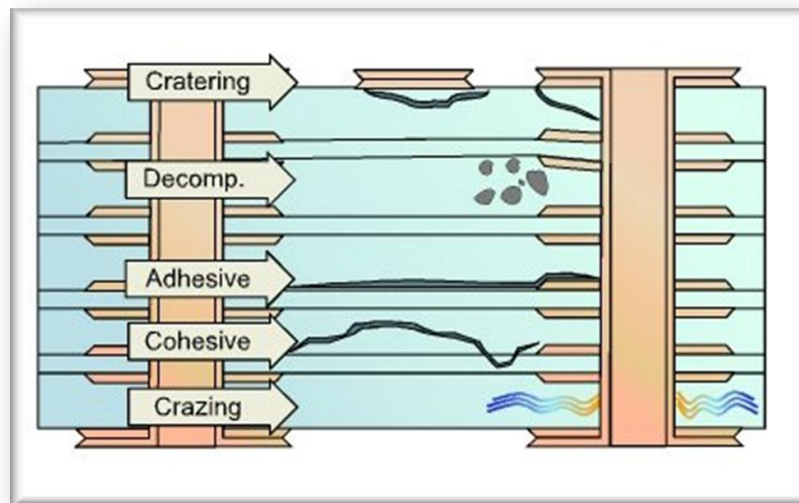
Based on morphology and failure modes, four types of material damage have been identified and are referred to, for the purposes of this paper, as: adhesive delamination, cohesive failure, crazing and material decomposition (figure 18). It appears that a fifth material condition often referred to as cratering is an associated failure mode but, cratering has not been expressed as an influence in thermal cycles to failure test PWBs and is not sensed by established capacitance measurements. Coupons with lifted (rotated) pads, that have dielectric attached to the pad, and associated cracks in the dielectric, may anticipate cratering in assembly.

Figure 18 – Overview of Types of Dielectric Damage

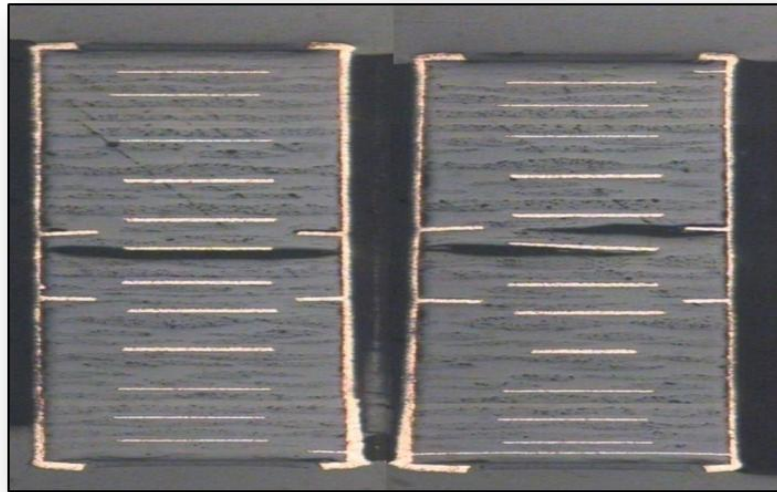
**Adhesive Delamination:** Adhesive delamination (figure 19) is a break between physical planes within the coupon. The most common is between the b-stage epoxy layer and c-stage or copper layers. On occasion the delamination will be between the epoxy and glass bundles but this is not to be confused with crazing where the crack is between epoxy and individual glass fibers. This type of delamination appears as round blisters or crosses and squares that are associated with warp and weft of the glass weave. Viewed in cross section cracks appear long and between laminated planes with pointed ends. It is thought that this failure may be a result of mechanical force being applied to the material like out gassing of volatiles or a failure of oxide coatings on internal copper traces or planes.

Figure 19 – Adhesive Delamination

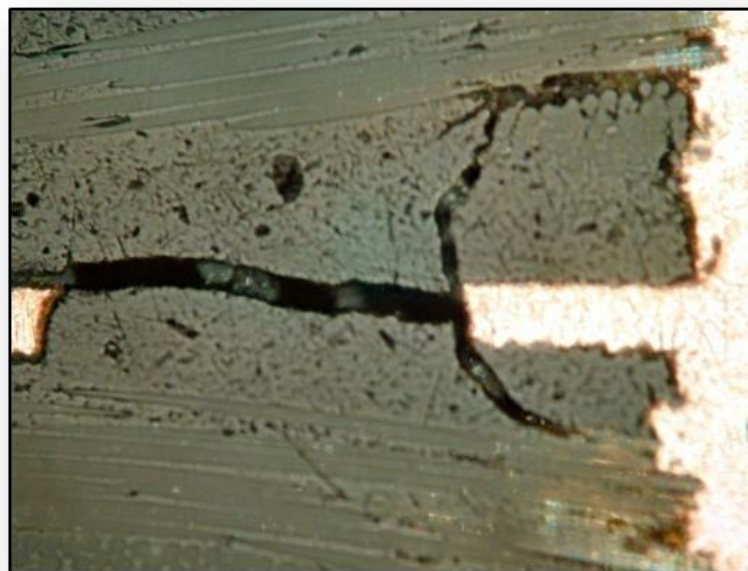
**Cohesive Failure:** Cohesive failure (figure 20) appears to be a failure of the epoxy system. The failure appears to be closely associated with a chemical degradation of the material and less a mechanical force induced failure. On cross section the cracks are not limited to a physical plane and may cross between b-stage and c-stage boundaries. The cracks are present as angular sections sometimes bifurcating into two arms.

Figure 20 - Adhesive Delamination

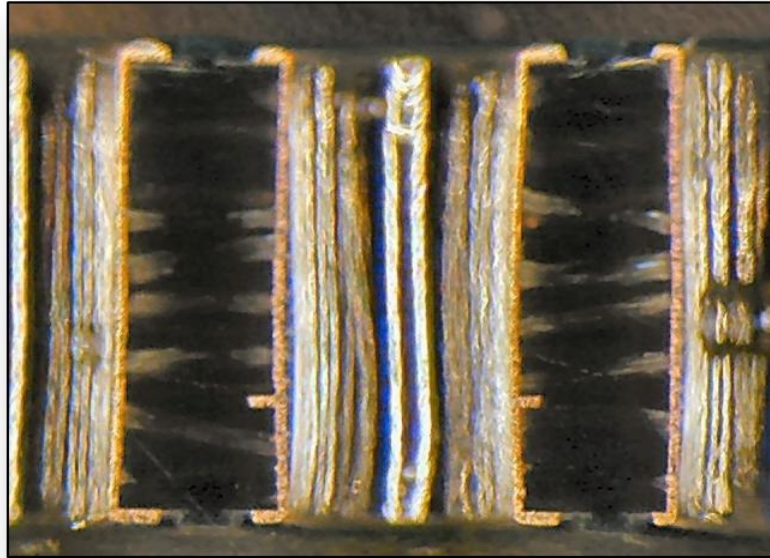
Crazing: Crazing (figure 21) may be defined as a separation between the epoxy and individual glass fibers in the dielectric material. The defect appears at the edge of a drilled hole and proceeds down the length of the glass bundle. On cross section the condition appears to refract light and can bridge between holes and adjacent interconnections. Crazing does not connect directly to internal traces as there is usually a butter coat of pure epoxy above and below internal traces and glass bundles. Crazing may connect directly to the adjacent PTHs and frequently copper is observed penetrating down the glass bundles (wicking) for a short distance. The sizes of the cracks along the glass fiber are such as they are most likely conducive to capillary action of liquids. This is the common path for CAF.

Figure 21 - Crazing along Glass Fibers – Longitudinal view between PTHs

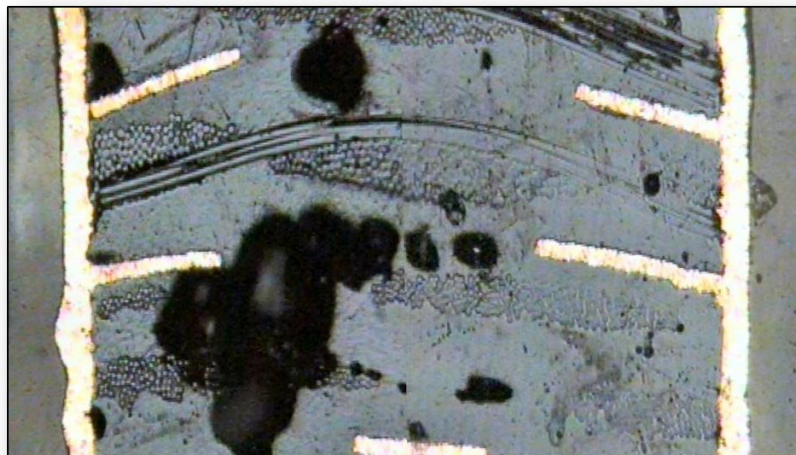
Material Decomposition: Material decomposition (figure 22) is infrequently observed. On occasion low performance materials are tested in lead-free applications with the result of carbonizing the dielectric material. On cross section decomposed materials present severe pad rotation with bubbles in a blackened epoxy. Decomposed material is frequently observed “oozing” out beside PTHs. It is obvious that decomposed material has boiled and burned.

Figure 22 - Material Decomposition
